**Flood Control Project Maintenance  
Levee Inspections**

## Maintenance Issue Types Only, Levee Inspection Report By Mile - Spring 2018

### Levee District No. 0001 (Glenn County)

Waterway	Bank	Unit Miles	Inspection Start/End	Inspector
Unit No. 01 Sacramento River	Right	12.23	03/08/2018 03/08/2018	Bob Duffey

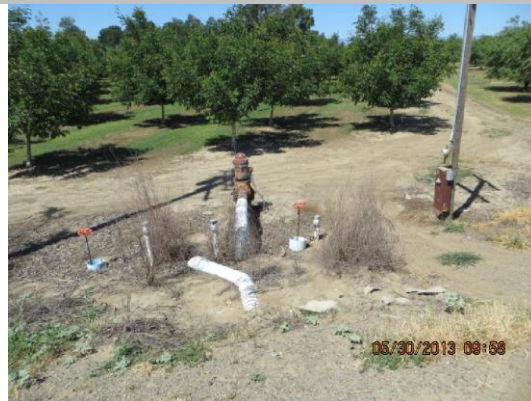
Photo 1 of 3 : UCIP\_SP\_2018\_14346\_23601.jpg

LM Start	5.51	Rating **	A/W	Issue No.	406
LM End	5.51	Issue Type +	Ma	Location *	
Category	Supplemental			GPS Latitude/Longitude	
				Start	End
Item	DWR UCIP LMA Responsibility			39.540546 °	39.540546 °
				-121.998981 °	-121.998981 °
DWR ID					
Comment Code					
Inspector Comment					
FS_ID:14346 DS_ID:22907 EP_NO: 344 Repair Type: No Action Needed Crossing Status: Found UCIP Comments: FIELD_STRUCT_DESC: 12-inch drainage pipe of an unknown material through the levee, 6.5 feet below the crown. Gate valve at the waterside (WS) toe. Air vent and pump at the landside (LS) toe. (Automatic Board Order (ABO) issued as Permit No. 9566, 1974 - B. and M. Giesbrecht). (Permit No. 344, Date Unknown - Alameda Sugar). [Additional Reference(s): DWR Levee Log, 1992. USACE Sacramento O&M Manual 140, May 1960, (HLM 5.61)]. FS Date: 5/30/2013

Pump, vent, and pipe on LS toe.

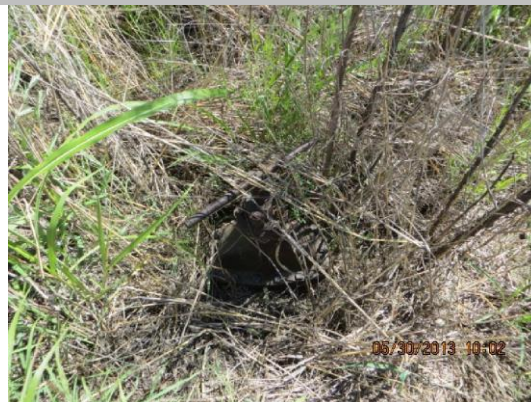
Photo 2 of 3 : UCIP\_SP\_2018\_14346\_23600.jpg

Gate valve on WS toe.

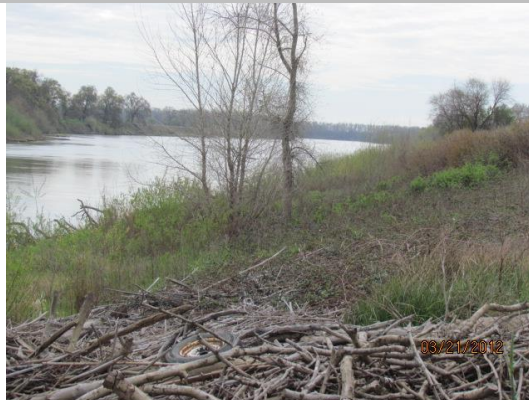
Photo 1 of 1 : SP\_2018\_LD0001G\_432\_10\_20180305\_00005.jpg

LM Start	6.38	Rating **	A/W	Issue No.	10
LM End	6.64	Issue Type +	Ma	Location *	WS
Category	Earthen Levee			GPS Latitude/Longitude	
				Start	End
Item	Vegetation			39.552691 °	39.556459 °
				-122.003063 °	-122.003831 °
DWR ID	DWR_LD0001G_01_s_2012_10				
Comment Code					
V8 : Environmental Requirements.					
Inspector Comment

View of the Army Corps of Engineers mitigation site.

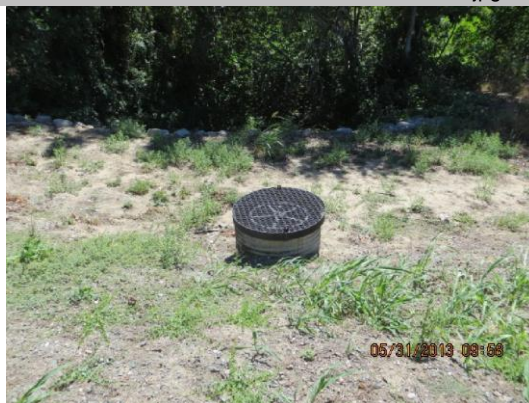
Photo 3 of 3 : UCIP\_SP\_2018\_16226\_27354.jpg

FS\_ID:16226  
DS\_ID:22919  
EP\_NO: 9562  
Repair Type: No Action Needed  
Crossing Status: Found  
UCIP Comments:  
FIELD\_STRUCT\_DESC: 24-inch corrugated metal drainage pipe with 0.375-inch wall epoxy coated steel sleeved through existing 30-inch corrugated metal pipe through the levee, 15 feet below the crown. Flap gate located on the waterside (WS) end. Slide gate in 44-inch corrugated metal riser unit on the WS slope. Concrete headwalls on both ends. Two corrugated metal cutoff walls. (24-inch pipe was authorized under Permit No. 9562-1, 2012 - Levee District No. 1 - Glenn County). (Original 30-inch pipe was authorized under Automatic Board Order (ABO) issued as Permit No. 9562, 1974 - L. R. Henrich). [Additional Reference(s): DWR Levee Log, 1992, 30-inch pipe listed. USACE Sacramento O&M Manual 140, May 1960, (HLM 8.98)].  
FS Date: 5/31/2013

Slide gate in 44-inch CMP riser on WS slope.

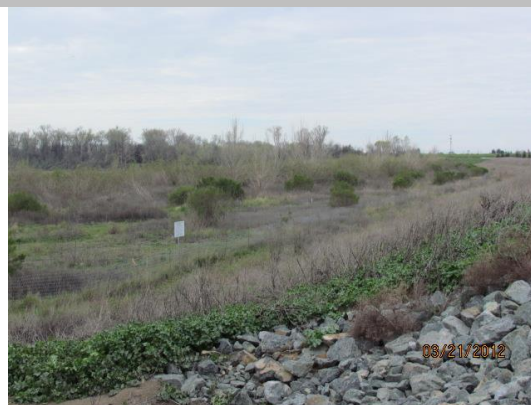
Photo 1 of 1 : SP\_2018\_LD0001G\_432\_8\_20180305\_00004.jpg

LM Start	9.50	Rating **	A/W	Issue No.	8
LM End	10.40	Issue Type +	Ma	Location *	WS
Category	Earthen Levee			GPS Latitude/Longitude	
				Start	End
Item	Vegetation			39.596192 °	39.607288 °
				-122.002573 °	-121.994565 °
DWR ID	DWR_LD0001G_01_s_2012_8				
Comment Code					
V8 : Environmental Requirements.					
Inspector Comment

View of the Army Corps of Engineers mitigation site.

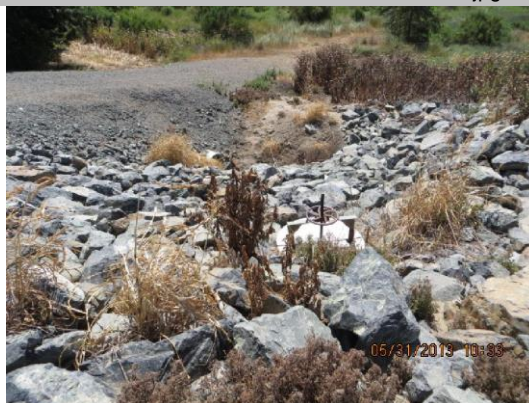
Photo 1 of 3 : UCIP\_SP\_2018\_14390\_23690.jpg

FS\_ID:14390  
DS\_ID:22921  
EP\_NO: 9559  
Repair Type: No Action Needed  
Crossing Status: Found  
UCIP Comments:  
FIELD\_STRUCT\_DESC: 24-inch corrugated metal drainage pipe through the levee, 11 feet below the crown. Flap gate located on the waterside (WS) end. Slide gate in 36-inch corrugated metal riser unit on the WS slope. Concrete headwalls on both ends. Two corrugated metal cutoff walls. (24-inch pipe [HLM 10.05] authorized under Automatic Board Order (ABO) issued as Permit No. 9559, 1974 - David and Mary Giesbrecht). [Additional Reference(s): DWR Levee Log, 1992. USACE Sacramento O&M Manual 140, May 1960, (HLM 10.05)].  
FS Date: 5/31/2013

Slide gate in 36-inch CMP riser on WS slope.

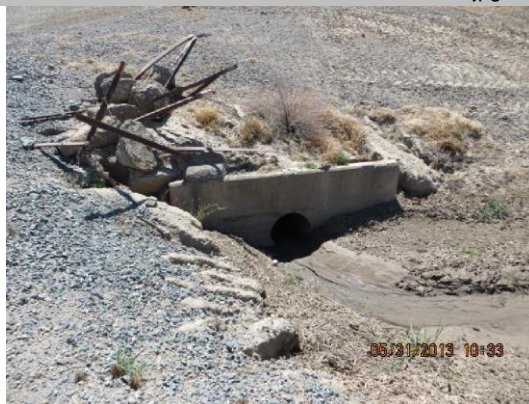
Photo 2 of 3 : UCIP\_SP\_2018\_14390\_23689.jpg

Concrete headwall and pipe at LS toe.

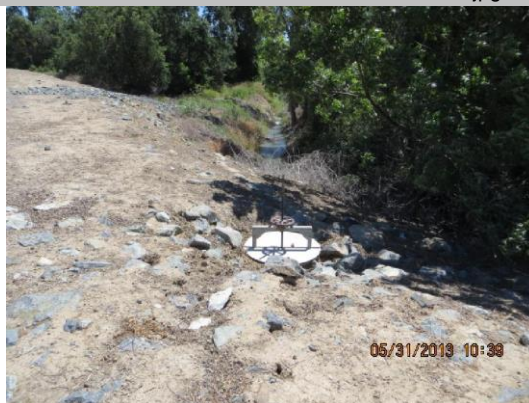
Photo 2 of 3 : UCIP\_SP\_2018\_14559\_23985.jpg

FS\_ID:14559  
DS\_ID:22922  
EP\_NO: 9558  
Repair Type: No Action Needed  
Crossing Status: Found  
UCIP Comments:  
FIELD\_STRUCT\_DESC: 24-inch corrugated metal drainage pipe through the levee, 11 feet below the crown. Flap gate located on the waterside (WS) end. Slide gate in 36-inch corrugated metal pipe riser unit on the WS slope. Two corrugated metal cutoff walls. Concrete headwalls on both ends. (24-inch pipe [HLM 10.08] authorized under Automatic Board Order (ABO) issued as Permit No. 9558, 1974 - Duard Geis). [Additional Reference(s): DWR Levee Log, 1992. USACE Sacramento O&M Manual 140, May 1960, (HLM 10.08)].  
FS Date: 5/31/2013 8:43:01 AM

Slide gate in 36-inch CMP riser on WS slope.

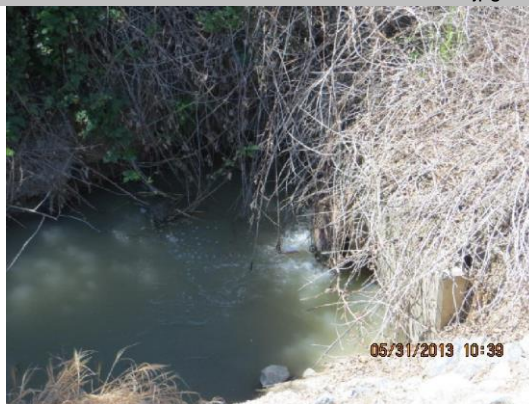
Photo 3 of 3 : UCIP\_SP\_2018\_14559\_23984.jpg

Pipe, flapgate, and headwall on WS toe.

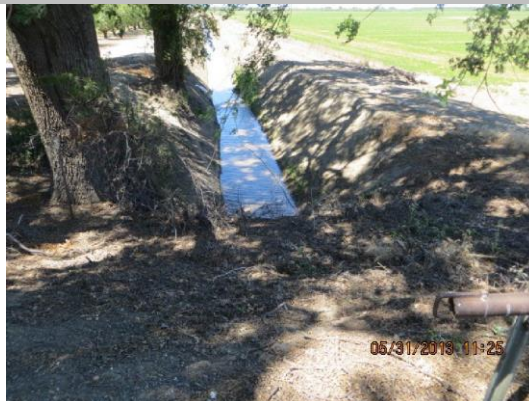
Photo 1 of 3 : UCIP\_SP\_2018\_14565\_24009.jpg

Comment Code					
Inspector Comment					
FS_ID:14565 DS_ID:22925 EP_NO: 9556 Repair Type: No Action Needed Crossing Status: Found UCIP Comments: FIELD_STRUCT_DESC: 48-inch corrugated metal drainage pipe through the levee, 11 feet below the crown. Flap gate on the waterside (WS) end. Concrete headwall on both ends. Slide gate in 60-inch diameter corrugated metal riser unit on the WS slope (48-inch pipe [HLM 11.17] authorized under Automatic Board Order (ABO) issued as Permit No. 9556, 1974 - Earl R. and Merrit R. Cooper). [Additional Reference(s): DWR Levee Log, 1992. USACE Sacramento O&M Manual 140, May 1960, (HLM 11.17)]. FS Date: 5/31/2013

Drainage ditch on LS toe.

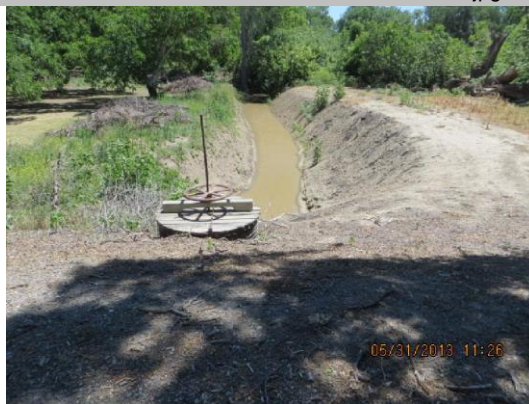
Photo 2 of 3 : UCIP\_SP\_2018\_14565\_24008.jpg

Slide gate in 60-inch CMP riser on WS slope.

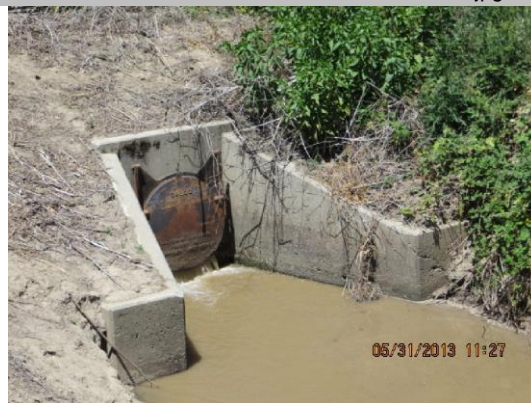
Photo 3 of 3 : UCIP\_SP\_2018\_14565\_24007.jpg

Item	DWR UCIP LMA Responsibility			39.616041 °	39.616041 °	
				-121.994450 °	-121.994450 °	
DWR ID						
Comment Code						
Inspector Comment						
FS_ID:14565 DS_ID:22925 EP_NO: 9556 Repair Type: No Action Needed Crossing Status: Found UCIP Comments: FIELD_STRUCT_DESC: 48-inch corrugated metal drainage pipe through the levee, 11 feet below the crown. Flap gate on the waterside (WS) end. Concrete headwall on both ends. Slide gate in 60-inch diameter corrugated metal riser unit on the WS slope (48-inch pipe [HLM 11.17] authorized under Automatic Board Order (ABO) issued as Permit No. 9556, 1974 - Earl R. and Merrit R. Cooper). [Additional Reference(s): DWR Levee Log, 1992. USACE Sacramento O&M Manual 140, May 1960, (HLM 11.17)]. FS Date: 5/31/2013

Flap gate and concrete headwall on WS toe.
